DEPARTMENT OF TRANSPORTATION**DIVISION OF ENGINEERING SERVICES**

Office of Structural Materials

Contract #: 04-0120F4Cty: SF/ALA Rte: 80 PM: 13.2/13.9File #: 13.28**WELDING INSPECTION REPORT****Resident Engineer:** Pursell, Gary**Address:** 333 Burma Road**City:** Oakland, CA 94607**Report No:** WIR-011648**Date Inspected:** 22-Jan-2010**Project Name:** SAS Superstructure**OSM Arrival Time:** 700**Prime Contractor:** American Bridge/Fluor Enterprises, a JV**OSM Departure Time:** 1530**Contractor:** Oregon Iron Works Clackamas, Or.**Location:** Clackamas, OR**CWI Name:** M. Gregson, J. Salazar**CWI Present:** Yes No**Inspected CWI report:** Yes No N/A**Rod Oven in Use:** Yes No N/A**Electrode to specification:** Yes No N/A**Weld Procedures Followed:** Yes No N/A**Qualified Welders:** Yes No N/A**Verified Joint Fit-up:** Yes No N/A**Approved Drawings:** Yes No N/A**Approved WPS:** Yes No N/A**Delayed / Cancelled:** Yes No N/A**Bridge No:** 34-0006**Component:** Hinge K Pipe Beams**Summary of Items Observed:**

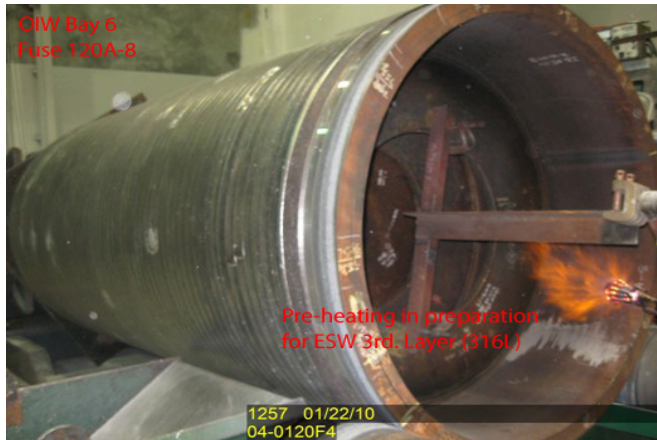
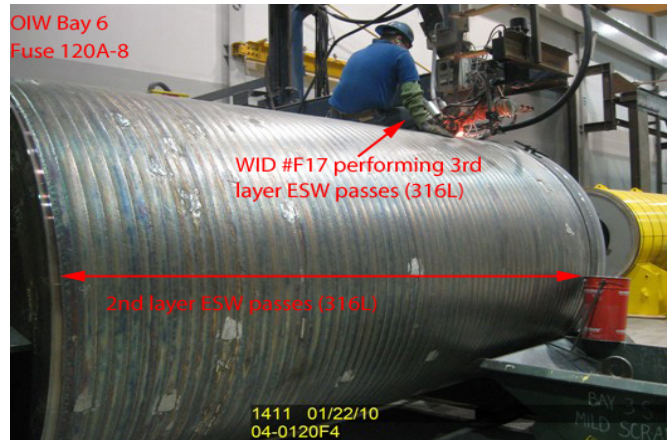
The QA Inspector witnessed welder WID #F17, Mr. Igor Frolov setting up to performing electro slag welding (ESW) on the third layer welding passes. The QA Inspector noted that a stationary torch was set up and pre-heat was being applied to the Fuse, to achieve the minimum 70 degrees Fahrenheit (21 C). The QA Inspector later witnessed Mr. Frolov performing the ESW. The QA Inspector randomly noticed QC Inspector Jose Salazar was present, to verify in-process welding parameters (amps/volts) and monitor in-process continuous pre-heat temperatures. QC Inspector Salazar explained to the QA Inspector that welding amperage was previously recorded at 1300 amps/25.7 volts, travel speed at 267mm/min. and a pre-heat temperature recorded at approximately 150 degrees Fahrenheit (66 C). The QA Inspector verified the welding parameters and the minimum pre-heat temperatures were in compliance with the applicable WPS 7003. The QA Inspector verified Mr. Igor Frolov was currently qualified for this welding process and position. The QA Inspector noted that the ESW being performed appeared to be in compliance with WPS 7003.
